Airworthiness Directives; Airbus Helicopters Deutschland GmbH (AHD)

Helicopters

2023-05-09 Airbus Helicopters Deutschland GmbH (AHD): Amendment 39-22378;
Docket No. FAA-2023-0430; Project Identifier MCAI-2022-01092-R.

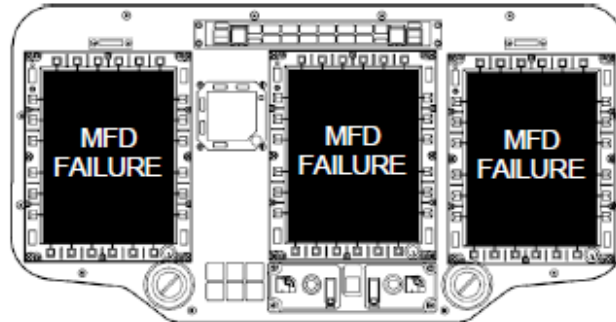
Figure 1 to paragraph (g)(2): RFM Emergency Procedure – Model MBB-BK117
Helicopters

- MFD FAILURE displayed on all MFDs
- If autopilot upper modes were coupled, they may decouple after 10 seconds (indicated by an „autopilot decouple“ voice message).

1. Aircraft trajectory
 - Maintain using IESI and stand-by compass.
 - Use AFCS “recovery” or “go-around” modes, if desired
 - Operate aircraft within the approved performance
2. MFD2 pb
 - OFF

4. MFD2
 - Maintain in FND format
5. LAND AS SOON AS POSSIBLE

4. VMC conditions – Establish
5. LAND AS SOON AS POSSIBLE

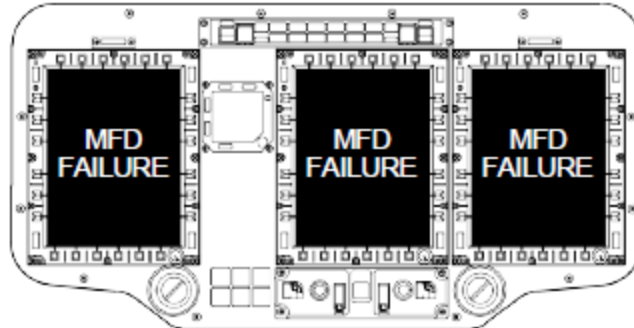
Figure 2 to paragraph (g)(2): RFM Emergency Procedure – Model EC135

- MFD FAILURE displayed on all MFDs
- If autopilot upper modes were coupled, they may decouple after 10 seconds (indicated by an „autopilot decouple“ voice message).

1. Aircraft trajectory
 - Maintain using IESI and stand-by compass.
 - Use AFCS "recovery" or "go-around" modes, if desired
 - Operate aircraft within the approved performance
2. MFD2 pb
 - OFF

4. MFD2
 - Maintain in FND format
5. LAND AS SOON AS POSSIBLE

4. VMC conditions – Establish
5. LAND AS SOON AS POSSIBLE
